A comprehensive Water Infrastructure Asset Management and Optimisation Project for North Sydney Council's Largest SWH Scheme

By: **Omid Sayar** – Optimal Stormwater

ABSTRACT

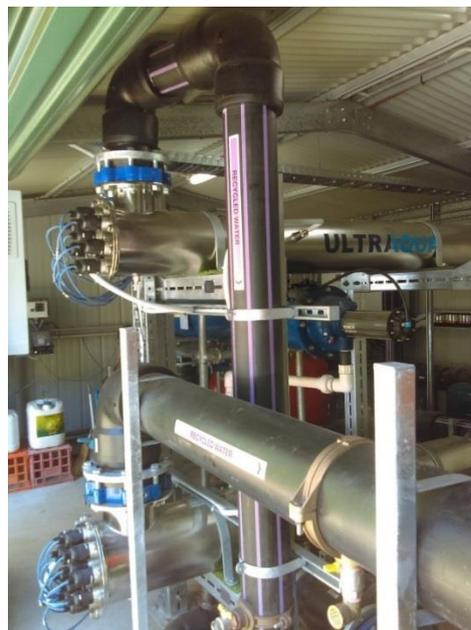
Figure 4 Two new UV Disinfection Units Installed in Cammeray Treatment Shed

Prior to this project, the Cammeray treatment room had no disinfection and the North Sydney treatment had an old system which was unreliable at best. As public health and safety has always been one of the major drivers for the entire project, we improved our treatment facilities by implementing an 18L/s high flow/high pressure UV for the Golf Course and a 4L/s new smart UV system for the parks (Forsyth, Tunks, and Primrose). The old UV was so temperamental it kept shutting the system down. Now we have state-of-the-art disinfection for all our water, and it's been validated to be working perfectly. Now the park users and the golfers can be happy, and safe too.

- 3.1. Recommissioning of two large Chlorination systems (including CT requirements)
- 3.2. Design and installation of three SMART UV systems (run the lamps based on the UVI at a designated set point)
