# Lessons learnt from Lalor Creek restoration works in Blacktown City Council

Catchment Projects Officer, Blacktown City Council, Blacktown, Australia

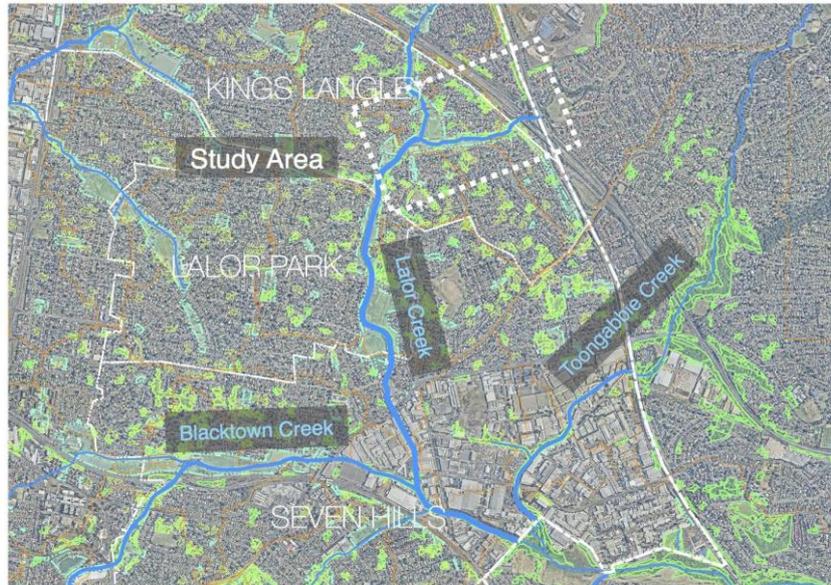
**Figure 1: Map of Lalor Creek and indication of the study site.**

The headwaters of Lalor Creek rise in the Hills Shire Council and flow south to the Blacktown Local Government Area (LGA) where the majority of the catchment lies. The Lalor Creek catchment is approximately 730 ha, and the catchment has approximately 37% total impervious cover (Blacktown Council 2017). Catchment land use is mainly residential, whilst there is also a small area of land with commercial uses, most land use intensification occurred in the late 80's and early 90's. The reaches subject to restoration are in the mid to upper catchment and combined are approximately 850 m long (Figure 1). Refer to Figure 4 for a detailed map of the different reach areas.

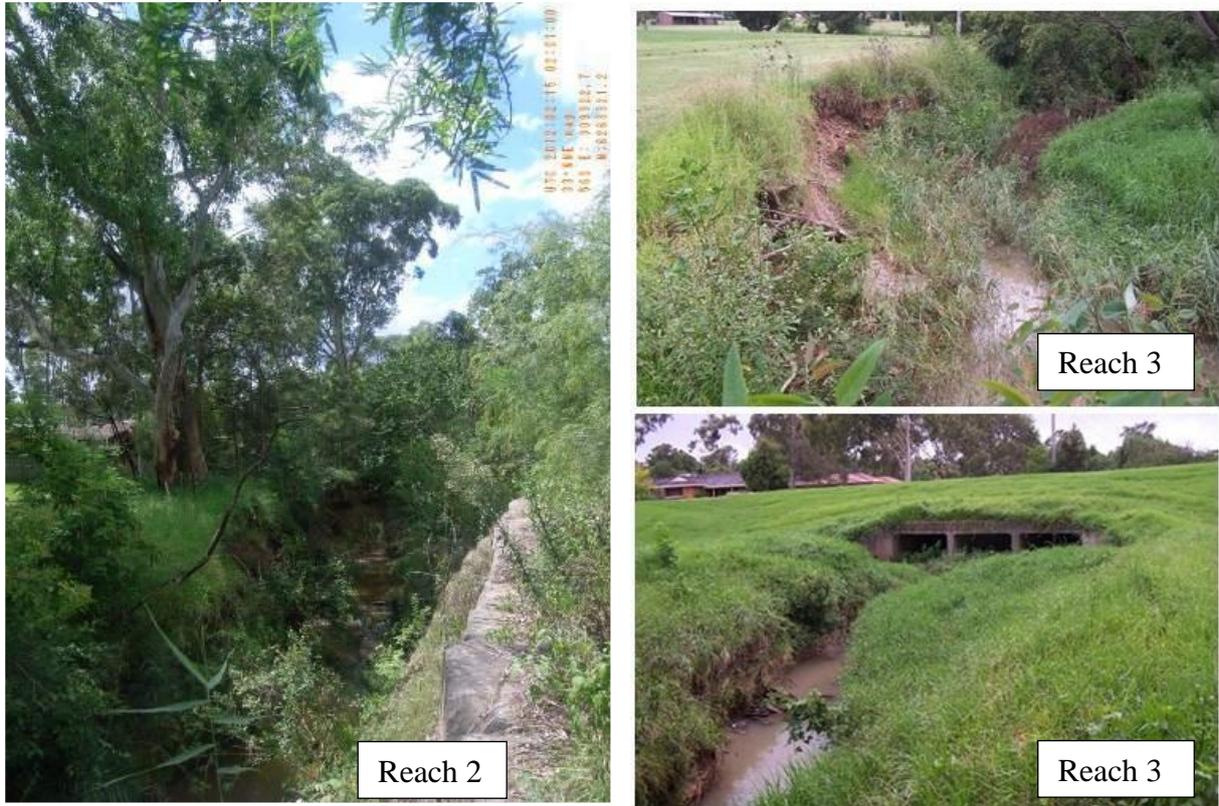
Figure 2 – Pre-construction photos of Lalor Creek in Reaches 2 and 3.

These Reaches of Lalor Creek required restoration as the creek bed was heavily incised, banks rapidly eroding and slumping, flood conveyance issues, and riparian vegetation was not providing any real ecological benefit as it was dominated by weeds and less than 10m wide in most areas. The images in figure 2 were taken pre-construction of both Reaches (2 and 3) and represent the degraded nature of the creek bed and banks.

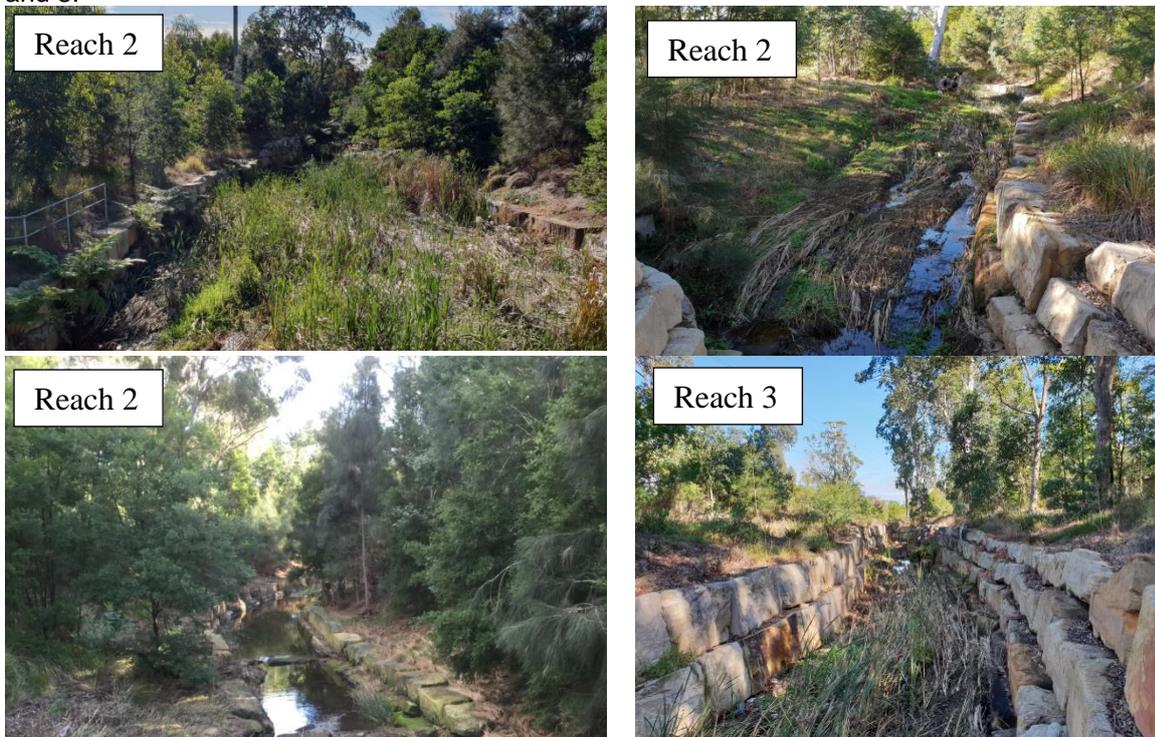
Figure 3: Images of Reaches 2 and 3 post construction.

The images in Figure 3 are a general representation of the post construction works in both Reach 2 and 3.

Due to site constraints, such as lack of available space with surrounding residential areas, existing services (power poles, Sydney Water sewer/potable pipeline etc.) and mature tree preservation, some sections of the creek banks have very steep banks that consist of stacked sandstone logs acting as a retaining wall. The stacked logs were required to protect services and to ensure the batter did not exceed a 3 to 1 ratio for safety reasons.

Three of the four of Councils objectives of the restoration works were met. Mitigation and amelioration against bed and bank erosion was achieved in both restored Reaches. Sandstone block lining of the bed and lower bank appeared to have stabilised the creek and evidence of sediment deposition was observed. In comparison, Reach 1 continued to be deeply incised, with significant bank slumping, undercutting and lack of sedimentation. It is unsurprising that the objective of erosion control was achieved as significant investment and hard engineering was applied to meet this investment and the end result is an approximately 850 m rock armoured channel which has been designed to protect the creek from further erosion.

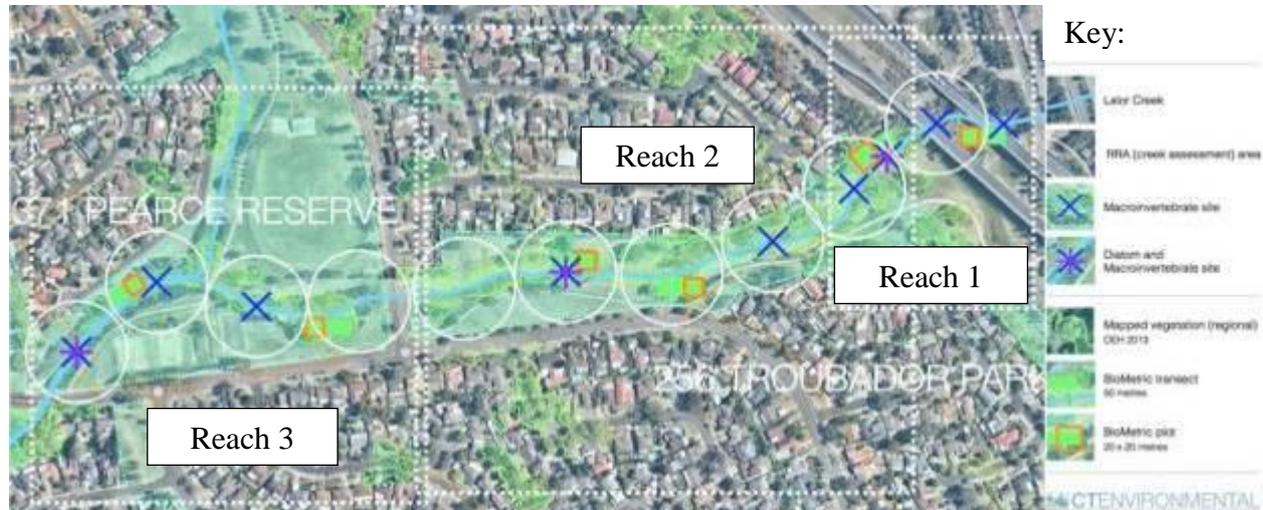
Figure 4: Map of post construction monitoring activities in each Reach.

To determine if the objectives of the creek restoration works were achieved CTENVIRONMENTAL and Blacktown City Council applied the following methods. Figure 4 below represents where these monitoring activities were undertaken.

To assess the relative conditions of riparian vegetation and creek channel, the Rapid Riparian Assessment (RRA) developed by Findlay et al (2011) and later refined by Dean and Tippler (2016) was applied. This method combines the assessment of both instream and riparian habitat metrics and was developed in the Sydney region for visual assessment of urban streams. Assessments were undertaken at 100 m intervals, which resulted in a total of 10 assessments being conducted; one (1) in Reach 1, five (5) in Reach 2 and four (4) in Reach 3.

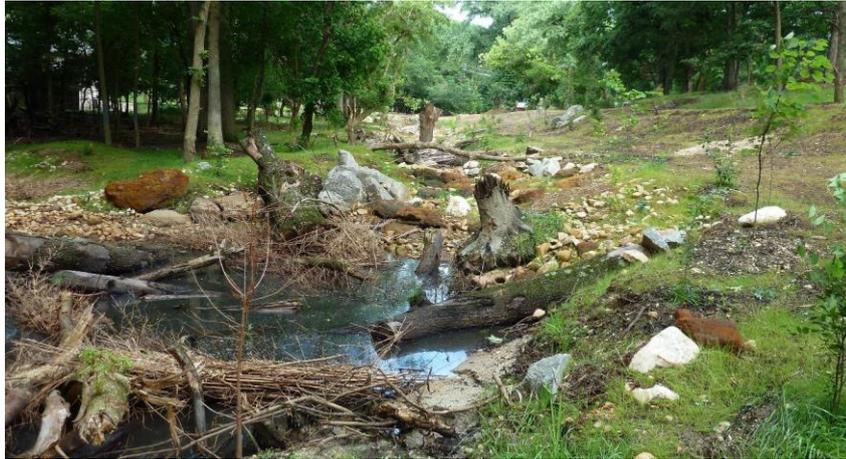
**Figure 8: Example of large woody debris integrated into an urban stream restoration project.**

- Given the limitations of reach-scale management, the objectives of **reach-scale restoration projects should focus on what is realistic**, including societal benefits.
- **Consider the addition of structural habitat complexity.** Fauna may be more likely to become established in restored reaches by incorporating wooden logs and debris in the creek channel during the design and construction phase, as woody debris provides ideal habitat for a range of native wildlife. Large wood can also protect banks from erosion, slow flows, encourage sediments to accumulate and aid establishment of in-stream vegetation (Figure 8). This approach has been used by many creek restoration projects and with appropriate planning can be integrated into urban stream restoration projects.
